connector at PP0 on cable coming from Service Tube (male) rear view

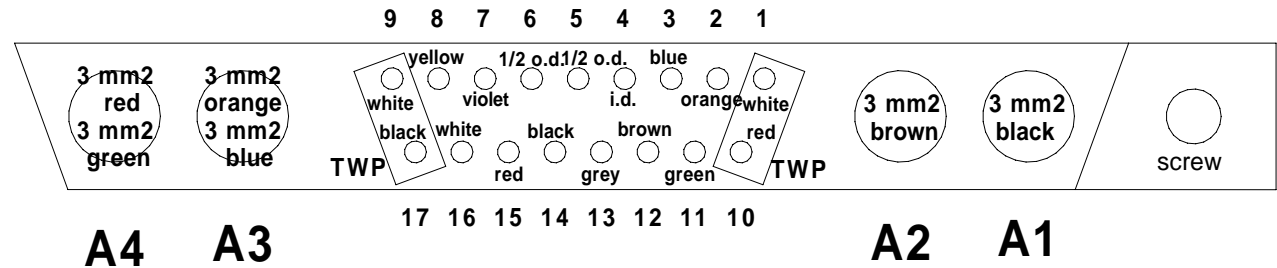
← Cable

A1	VAX+	1	VAX- sense	7	V_BIAS_X1_RTN	13	V_BIAS_X24
A2	VAX-	2	V_BIAS_X21	8	V_BIAS_X11	14	V_BIAS_X12
A3	VDX-	3	V_BIAS_X2_RTN	9	VDX- sense	15	V_BIAS_X13
A4	VDX+	4	inner drain	10	VAX+ sense	16	V_BIAS_X14
		5	1/2 outer drain	11	V_BIAS_X22	17	VDX+ sense
		6	1/2 outer drain	12	V_BIAS_X23
